An Electrostatic Hazards Evaluation of RAAF Flightline Clothing

Ship Structures and Materials Division Aeronautical and Maritime Research Laboratory

DSTO-TR-0372

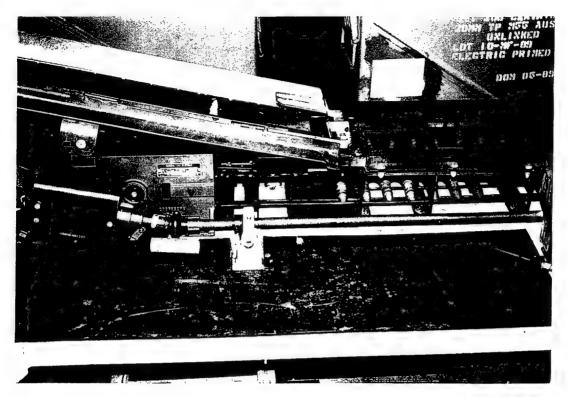
Figure 1: A replenisher assembly.

Resistance measurements (Table 13) were conducted on the replenisher assemblies to determine whether all the conducting sections were electrically bonded and that the assembly was earthed. All resistances were measured at an applied potential of 250 V and all values were low except for the drive socket and the sloping tray. These are acceptable values, however, from the point of view of electrostatic dissipation. Unless stated otherwise the assembly serial no. was 3000072.

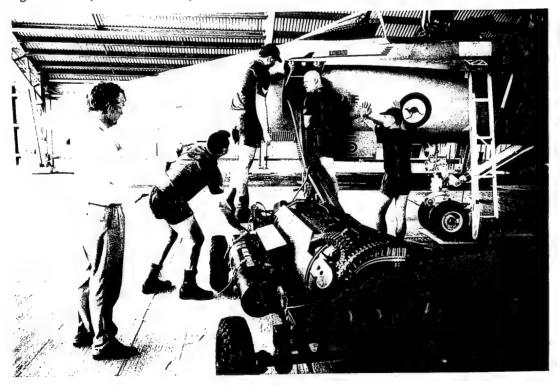
Figure 2: A loader assembly

The body-to-ground resistance of an operator standing on the AMRL-constructed painted metal platform (Section 2.2) while wearing the "Statsafe" antistatic shoes was $10^9~\Omega$. When the operator, wearing the antistatic shoes, stood on the unpainted metal platform his resistance to ground was measured as $10^7~\Omega$. These measurements were conducted at an applied potential of 500 V and the results indicate that the presence of a paint layer on the platform significantly increases the body-to-ground resistance.

Resistance measurements were also conducted on the loader assemblies at an applied potential of 250 V (Table 14). Wheel resistance measurements are shown in Table 15 and resistance measurements between the assembly drum and earth are presented in Table 16. Resistances are below $10^9~\Omega$ for all measurements which is acceptable for electrostatic purposes. The measurements in Table 15 were conducted with the wheel resting on a metal plate on the floor. The purpose of these measurements was to determine whether the loader assemblies provided a path to earth of sufficiently low resistance to dissipate electrostatic charge and also to determine whether the assembly components were bonded together.

- (5) It is also recommended that the metal surface of the loader platform be left in an unpainted state. If the platform has a previously painted surface then this paint should be removed before the platform is placed in service.

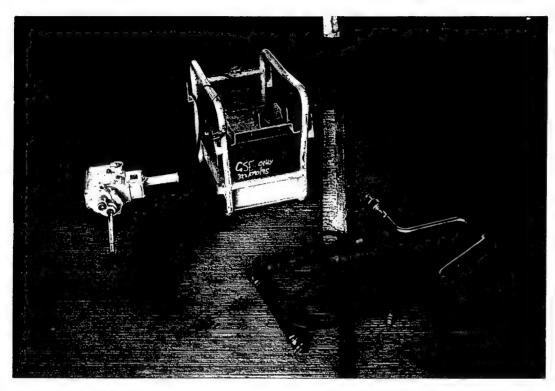
Figure 3: The three different types of loader drive unit

The electrically powered loader drive unit was tested to check whether its operation could generate a static charge. An operator wearing brown GP boots stood on a polyethylene sheet, picked up the loader drive unit and started the motor. No electrostatic potential was detected on the loader drive unit when it was operated in this way and therefore no evidence was found for the assertion that an operating electric loader drive unit could generate a static electric charge.
